Final Report No. 1793

concerning the accident
to the aircraft AVRO 146-RJ100, HB-IXM,
operated by Crossair under flight number CRX 3597,
on 24 November 2001
near Bassersdorf/ZH

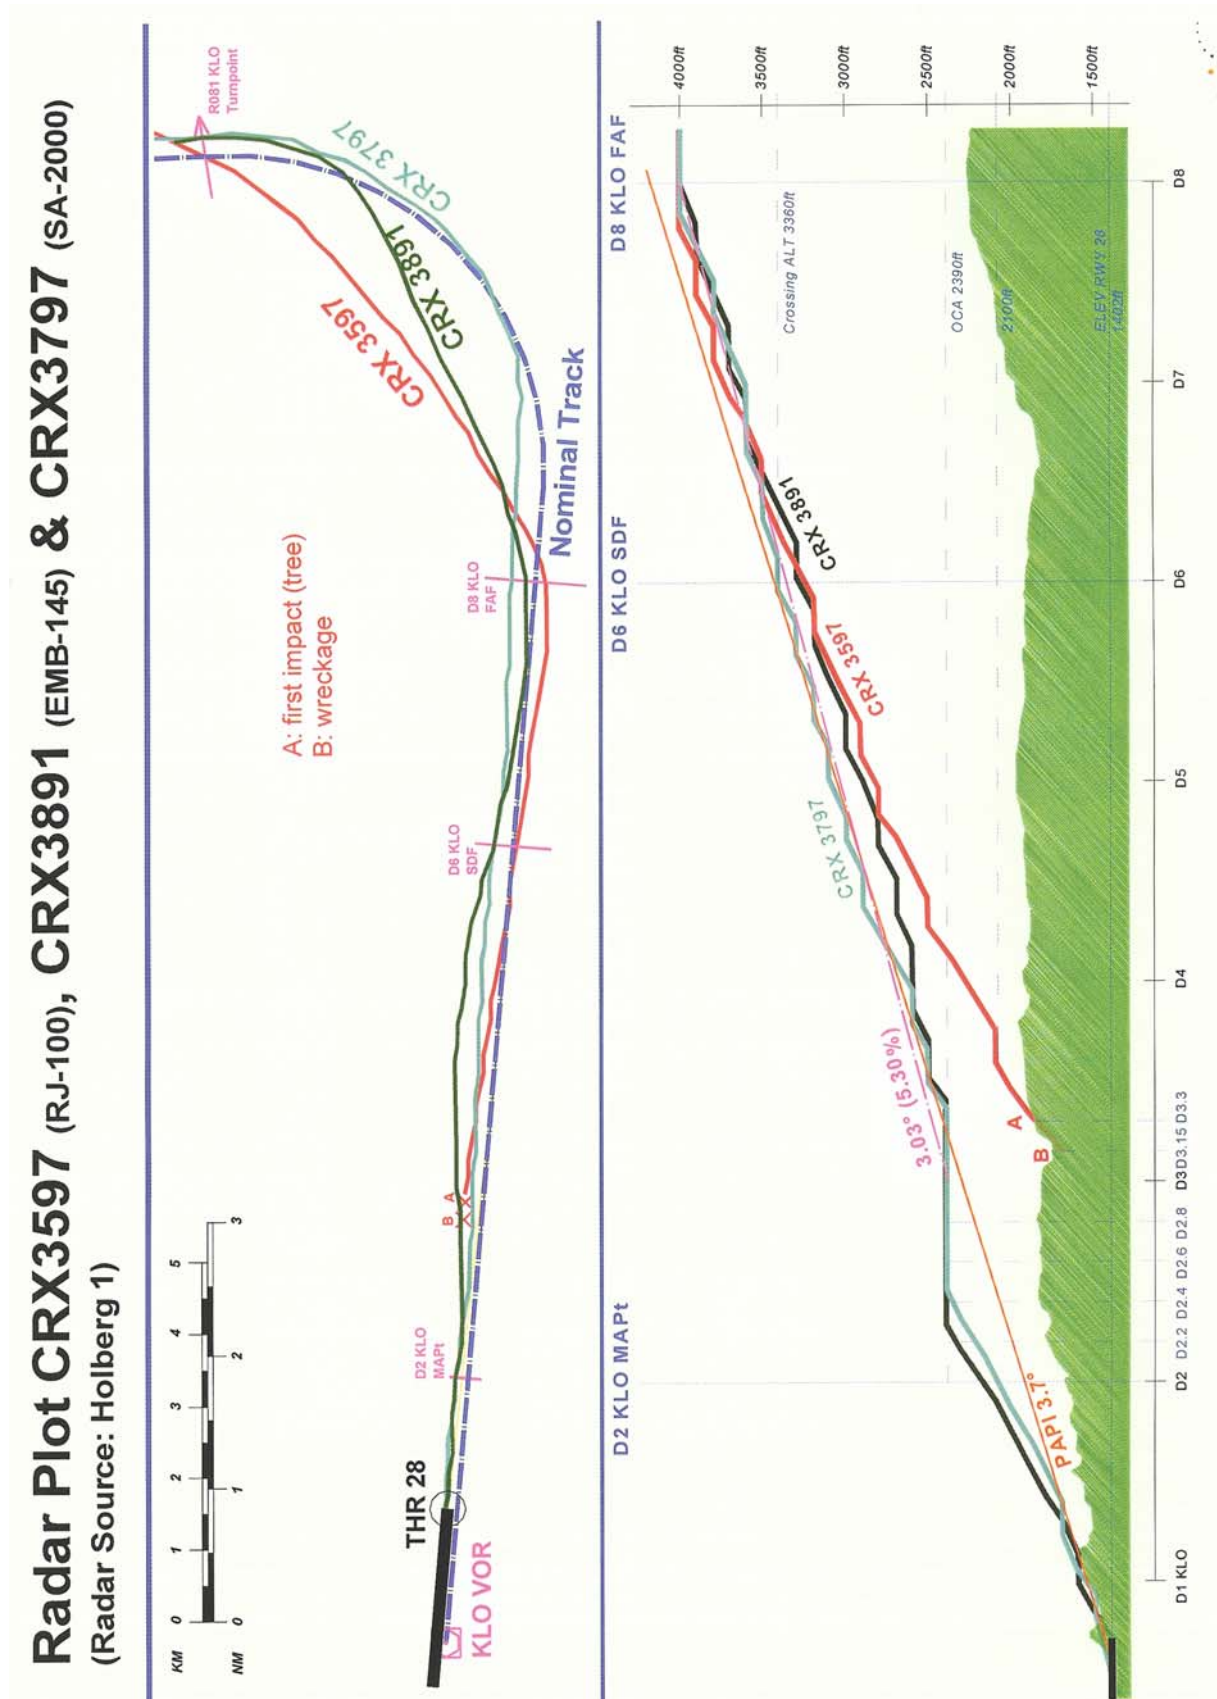
Appendix 4: Approach Profile of Flight CRX 3597

The accident is attributable to the fact that on the final approach, in own navigation, of the standard VOR/DME approach 28 the aircraft flew controlled into a wooded range of hills (controlled flight into terrain – CFIT), because the flight crew deliberately continued the descent under instrument flight conditions below the minimum altitude for the approach without having the necessary prerequisites. The flight crew initiated the go around too late.

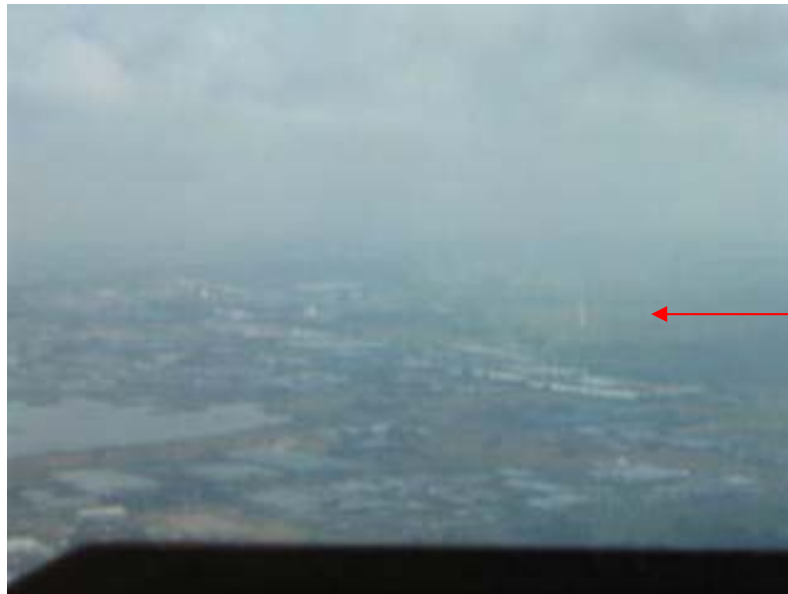
The following picture was made in reality. The aircraft was located as well approx. 1000 ft (MDA) above the threshold elevation on a three degree approach path. The meteorological conditions were as follows: Broken 2000 ft with a visibility of 5000 m.

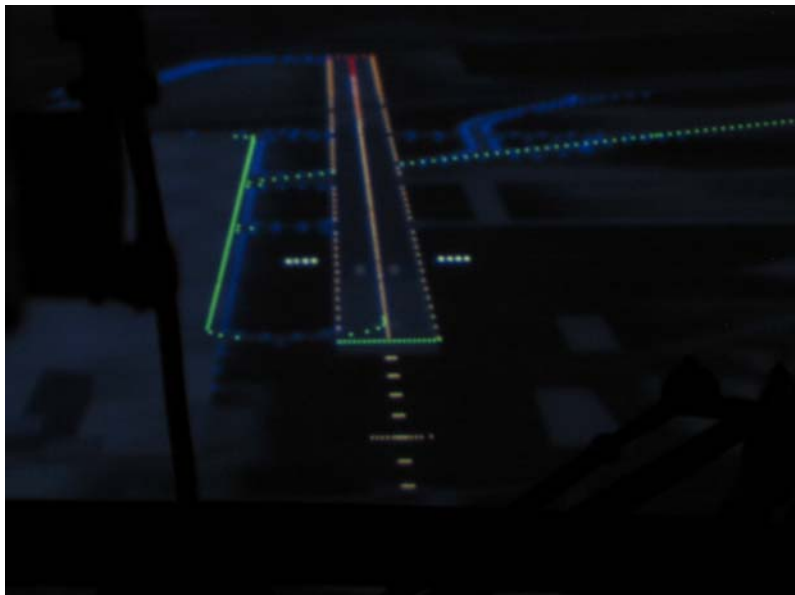
Approach lights

The picture below shows the visual situation as seen by the pilot of an aircraft being at the minimum descent altitude, and approaching the missed approach point with a visibility of 10 km. More or less out of this situation the two preceding traffic CRX3891 (at D2.2 KLO) and CRX3797 (D2.4 KLO) started their final approach descents for landing.

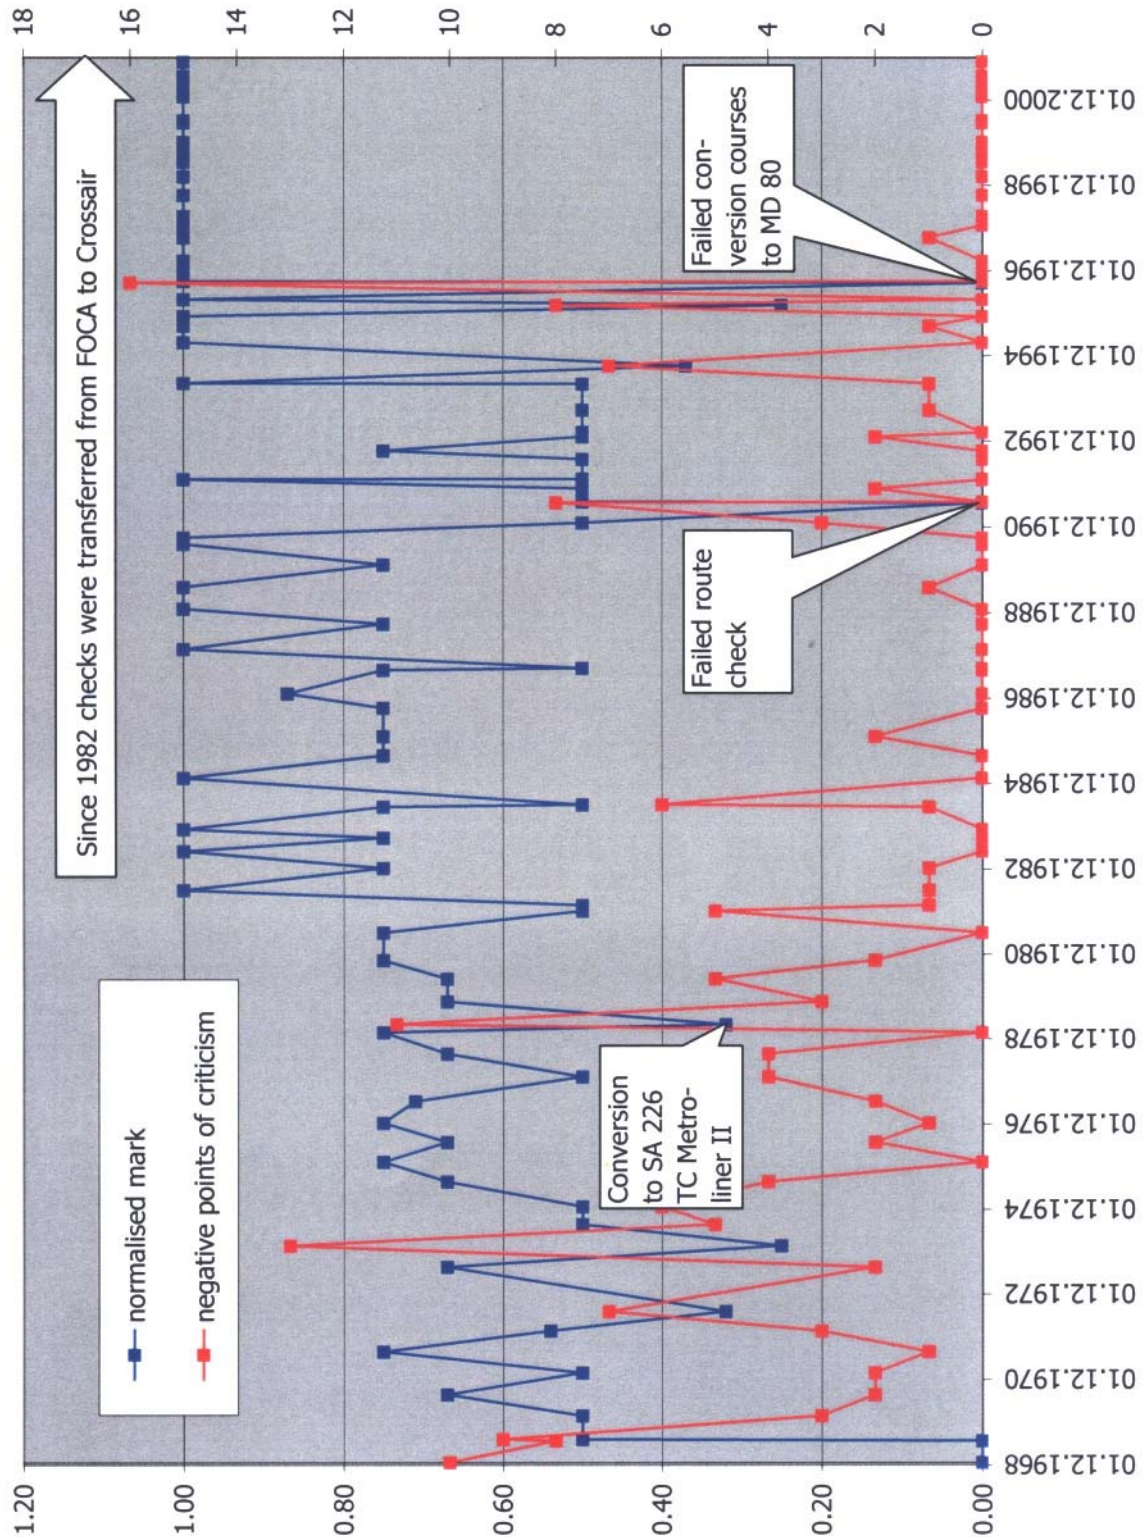
Appendix 9

Graphical compilation of the results of the commander's line, route and simulator checks. Since the marking scale varied over time, the marks were normalised so as to make direct comparison possible (blue data series). A value of 0.5 therefore corresponds to average performance. The number of negative points of criticism mentioned on the checksheets has also been entered (red data series).
